# NAPA Tech TIPS

## GM "W" Body Calipers Seized

**Application:** G.M. "W" body vehicles

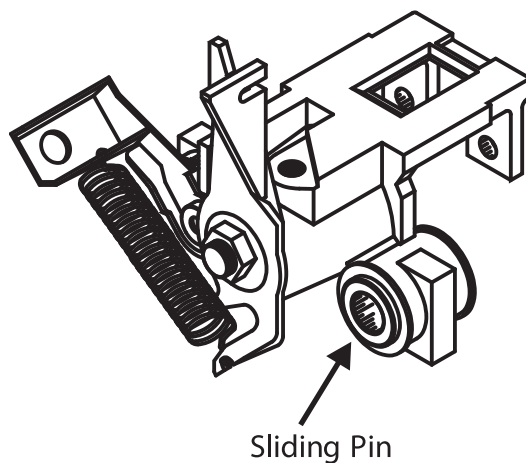
**Problem:** Corrosion causing the slider pin to seize in the caliper.

**Cause:** The use of dissimilar metals in the original design results in corrosion in the caliper slider pin bore, causing the slider pin to seize.

**Solution:** NAPA caliper part numbers 18-4295, 18-4296, 18-4327 and 18-4328 have a redesigned slider pin and a new dust boot. The redesigned pin allows more high temperature synthetic lubricant to be retained in the slider pin bore, preventing the pin from seizing.
