# NAPA Tech TIPS

## Explanation of caliper letter codes: SE1887 or SE1887B

**Application:** Ford Escort, EXP, ZX2 1991-2001 Front Caliper Loaded or Unloaded.

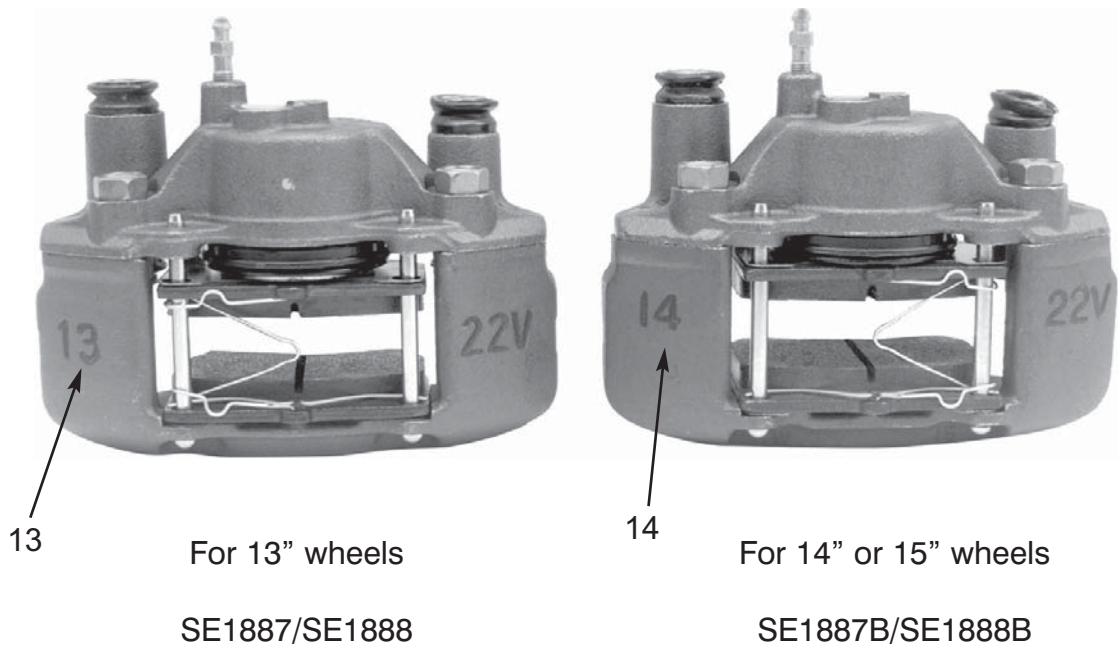
**Solution:** Counterperson must make sure customer gets the correct caliper for the application. Please reference the catalog for specific applications. The pictures below show casting numbers that can be used to assist in caliper identification.
